## Septic Lateral Inspection · Sample Report

Prepared for a homeowner · Sandpoint, ID area · July 2026

The 4" building sewers (septic laterals) serving both the house and the shop were video inspected to assess their structural condition and function. The inspection covered accessible lengths from entry points at the house and shop cleanouts, and included digital locating to determine depth and identify tie-ins.

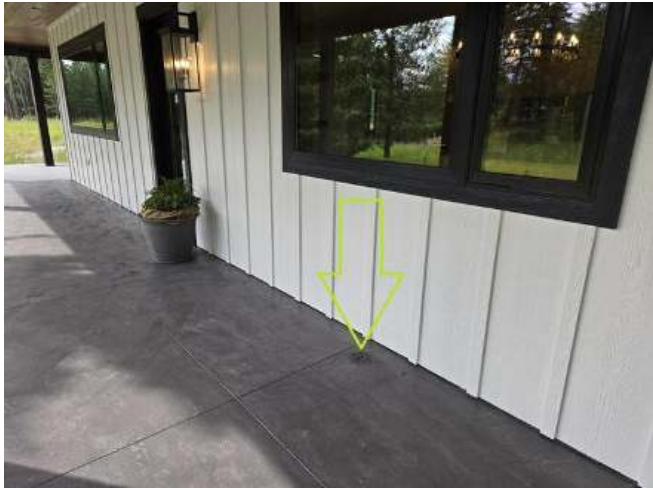
**CLEANOUT LOCATION/CAMERA ACCESS**  
MAIN HOUSE - NE PATIO

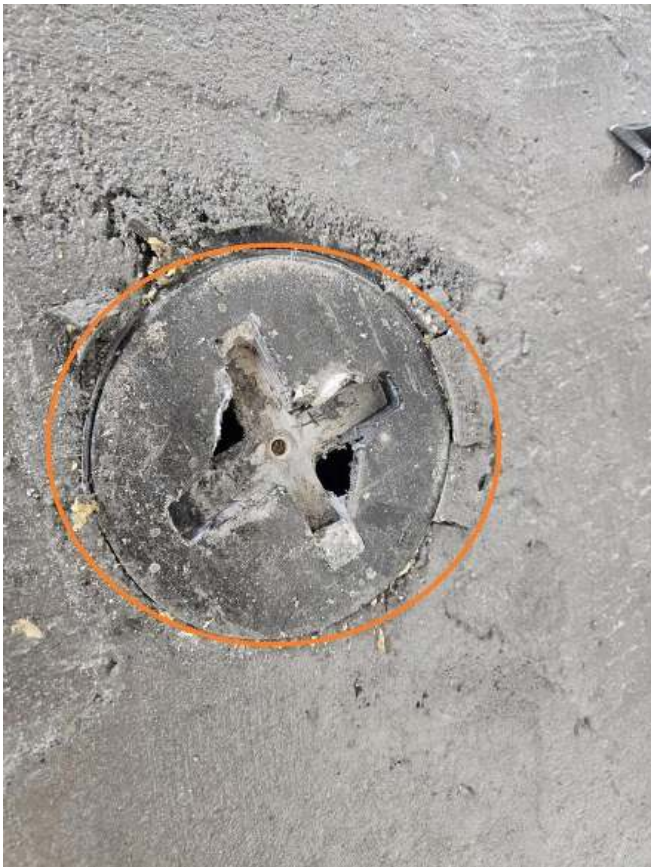
**CLEANOUT PLUG CONCRETED OVER**  
BROKE DURING REMOVAL - REPLACED WITH NEW ABS PLUG

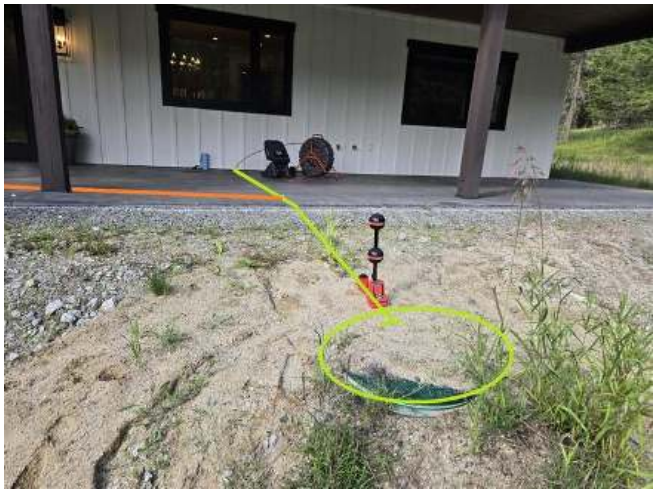
**MAIN HOUSE LATERAL**  
INLET TO SEPTIC TANK - SEPTIC TANK RISER (CIRCLED) - ORANGE LINE IS  
TIE-IN FROM SHOP LINE

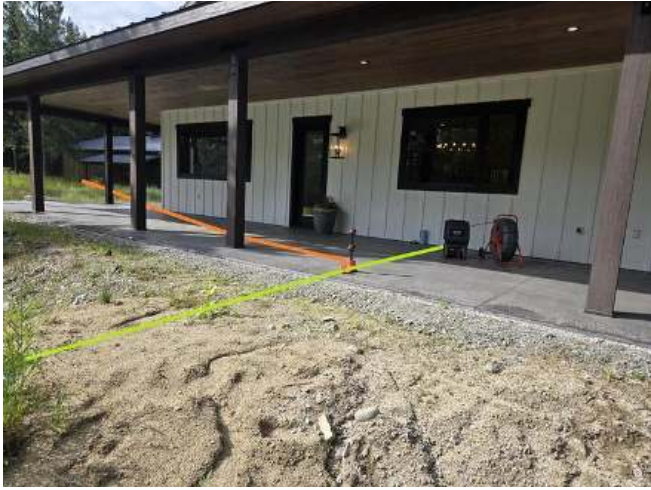
**APPROXIMATE LOCATION OF LATERALS**  
HOUSE AND SHOP COMBINED

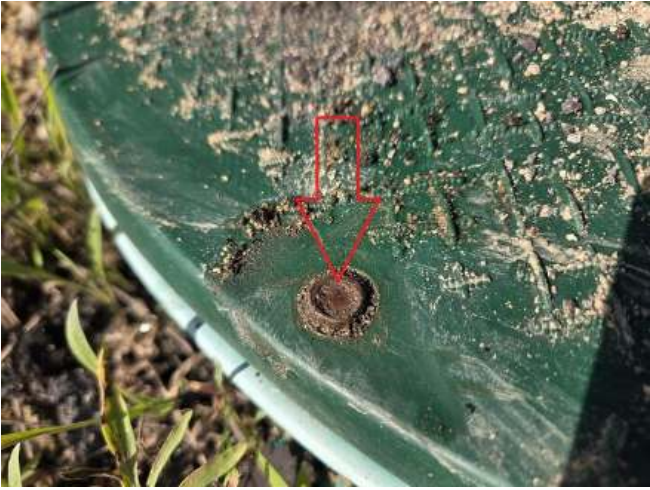
**SCREWS FOR RISER LID**  
RUSTED AND ROUNDED OUT - UNABLE TO REMOVE WITH STANDARD SOCKET - INSTALL NEW SCREWS

Septic Riser - Install new screws.

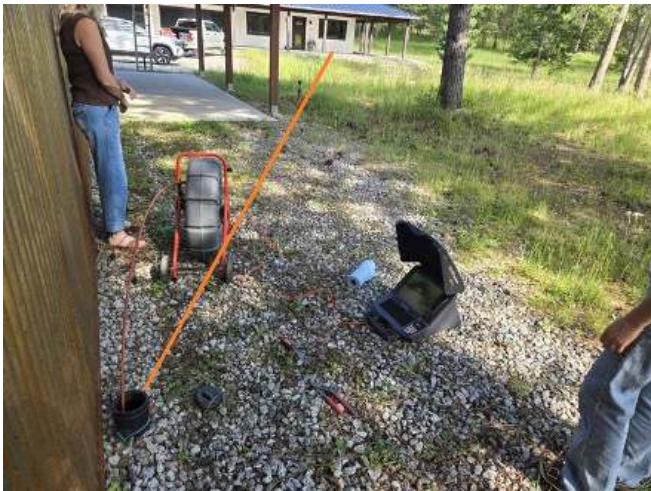
**APPROXIMATE LOCATION OF SHOP LATERAL**  
CLEANOUT LOCATION LOOKING NORTH TOWARD HOUSE

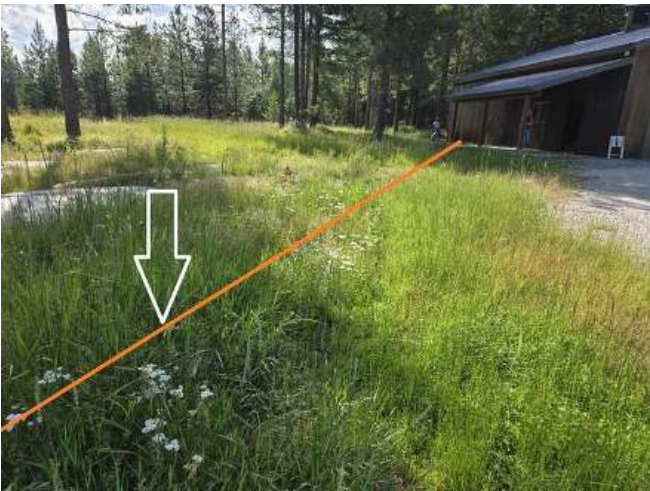
**APPROXIMATE LOCATION OF SHOP LATERAL**  
WHITE ARROW INDICATES LOCATION OF SECOND CLEANOUT SEEN IN VIDEO - DID NOT APPEAR TO HAVE RISER TO ABOVE GROUND LEVEL - A GREEN VALVE BOX EXISTS IN THIS LOCATION, THOUGH APPEARED TO BE FILLED WITH DIRT

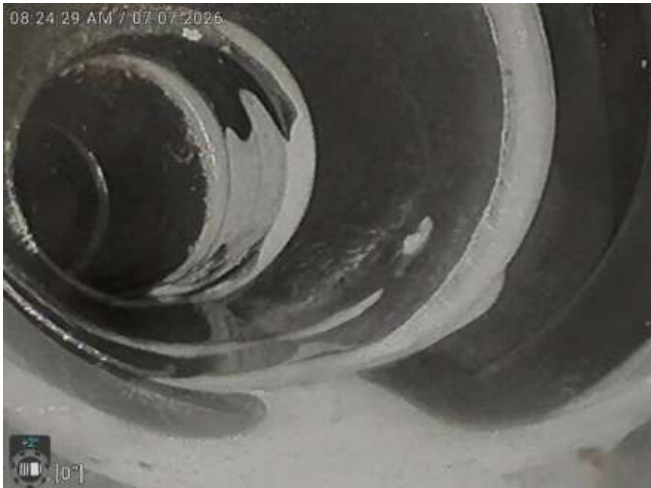
**HOUSE LINE**  
ABS PIPING - CLEAN AND CLEAR IN GOOD STRUCTURAL CONDITION

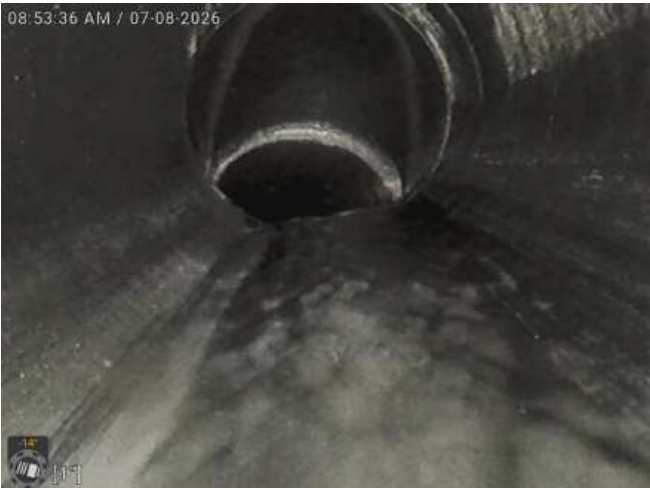
**HOUSE LINE**  
ABS PIPING - TOP OF VERTICAL ELEVATION CHNAGE

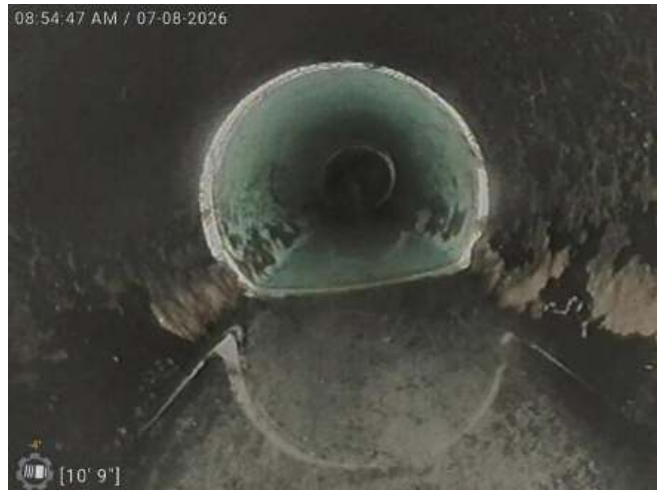
### HOUSE LINE

ABS TO PVC TRANSITION - MINOR LOW SPOT WITH STANDING WATER - MINOR ACCUMULATION OF SLUDGE

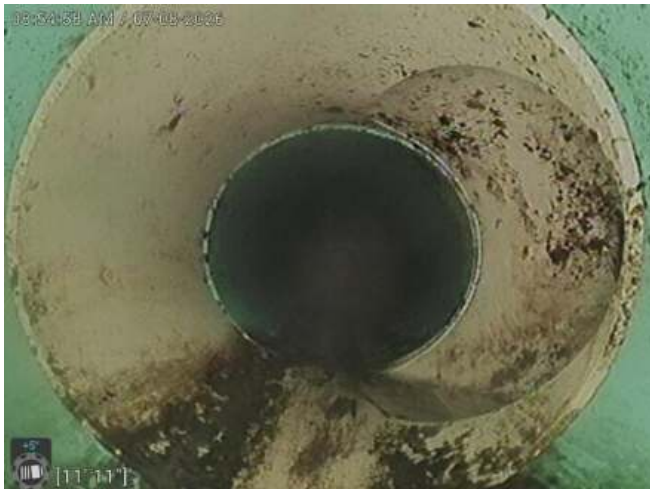
### HOUSE LINE

TIE-IN FROM SHOP - WYE FITTING APPEARS TO BE NEGATIVE GRADE

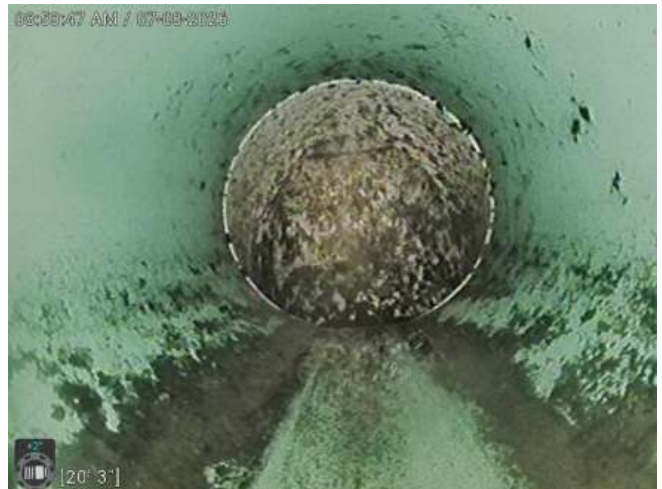
### HOUSE LINE

PVC PIPING - MINOR ACCUMULATION OF SLUDGE AND SCALE

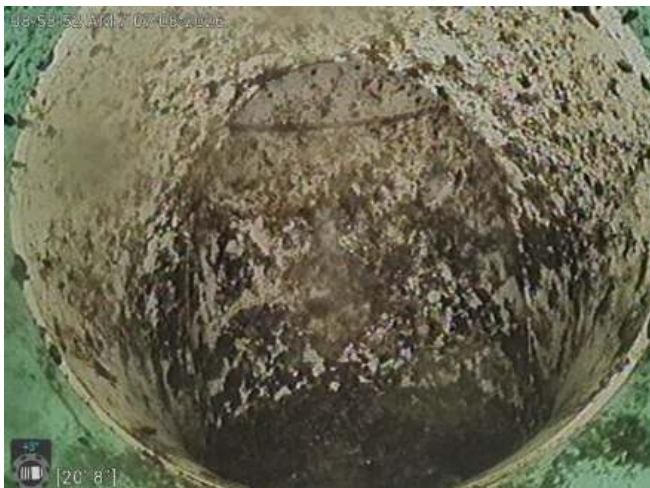
### HOUSE LINE

INLET TO SEPTIC TANK - PVC SANITARY TEE BAFFLE

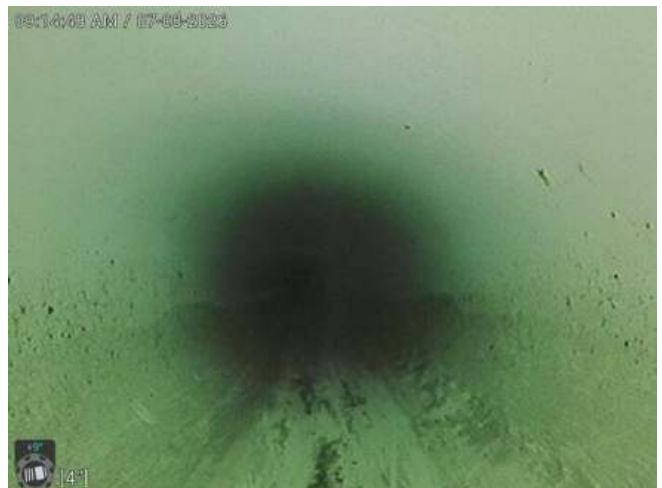
### SHOP LINE

CLEAN AND CLEAR

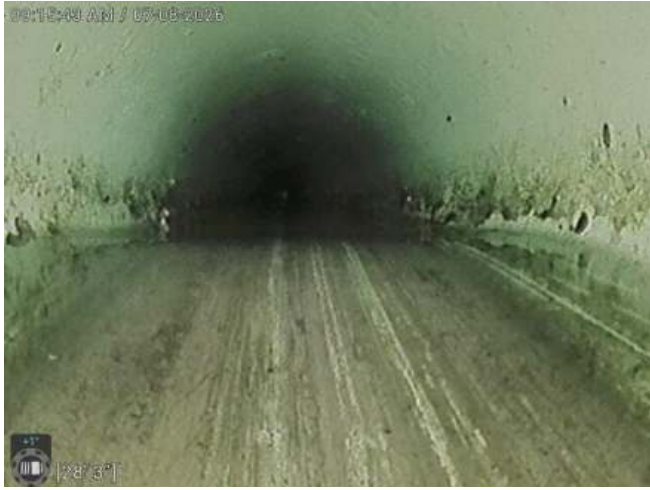
#### SHOP LINE

HUMP IN LINE DUE TO ROCK OR OTHER FOREIGN DEBRIS UNDER PIPE BED

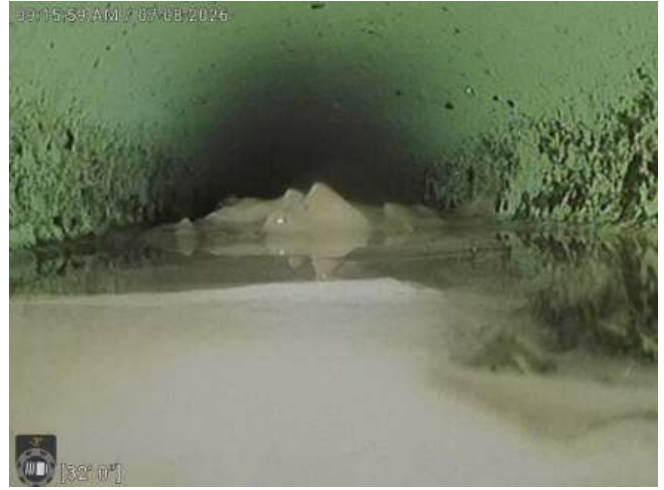
#### SHOP LINE

BELLY - LOW SPOT HOLDING WATER - PAPER SITTING IN LINE

No repairs or maintenance were required for the main house line. The shop line appears to be maintainable with routine hydro-jetting, but frequent maintenance may be necessary to prevent backups due to the existing bellies and grade issues. It is unknown when the septic tank was last pumped. It is recommended to have the septic tank pumped every 3-5 years.

Shop - It is recommended to install a dedicated septic system for the shop with guidance from the Panhandle Health District, as frequent ongoing maintenance of the current lateral may be necessary to prevent backup issues. Alternatively, a grinder pump system may be an option to carry waste from the shop to its tie-in with the main house line.

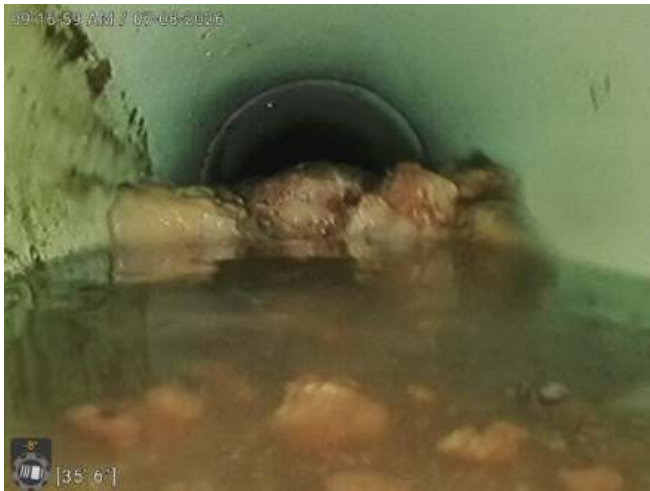
#### SHOP LINE

BELLY - SEVERE ACCUMULATION OF PAPER AND SOLIDS

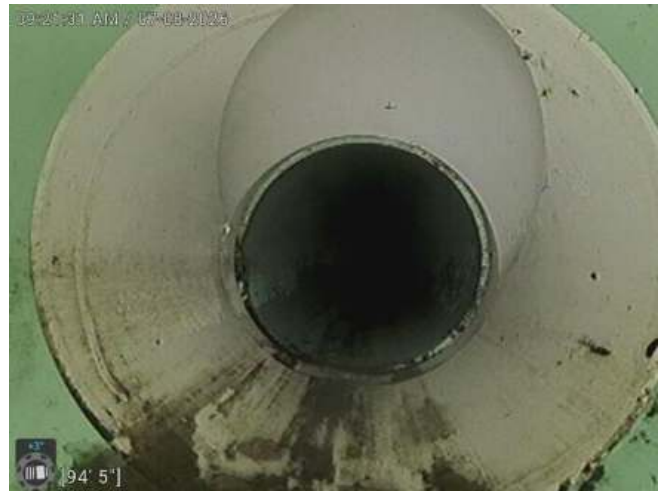
#### SHOP LINE

SECOND CLEANOUT SEEN IN VIDEO - DID NOT APPEAR TO HAVE RISER ABOVE GROUND LEVEL

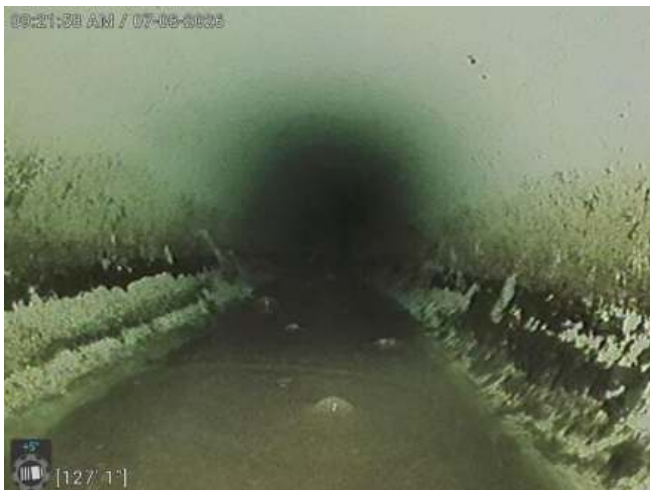
#### SHOP LINE

NEGATIVE GRADE - STANDING WATER - MODERATE ACCUMULATION OF SLUDGE

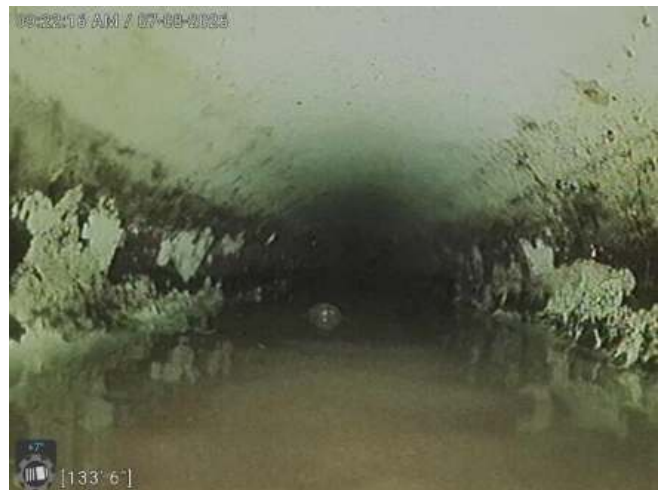
#### SHOP LINE

SEVERE ACCUMULATION OF SLUDGE IN BELLIED SECTION OF PIPING - APPROX. 2" LOW

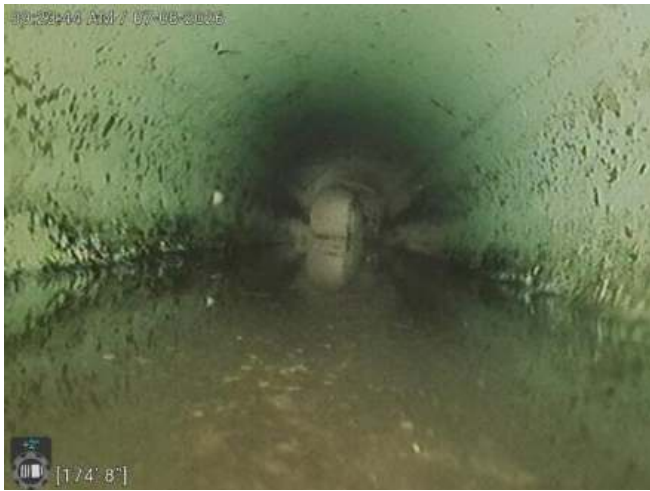
#### SHOP LINE

MODERATE BELLY - STANDING WATER MODERATE ACCUMULATION OF SLUDGE

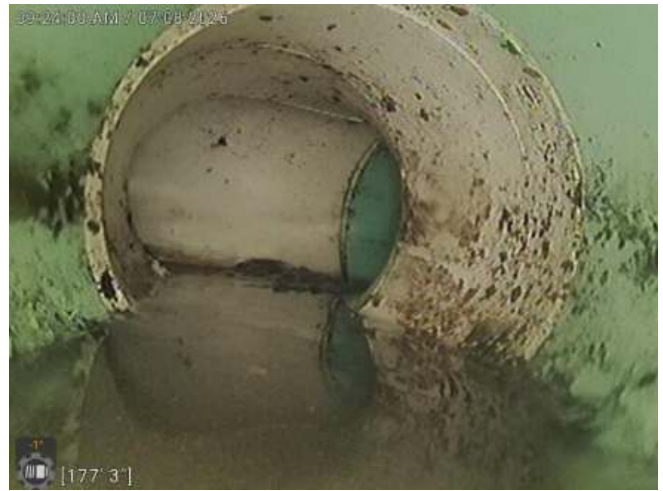
#### SHOP LINE AT TIE-IN WITH HOUSE

STANDING WATER - ACCUMULATED SLUDGE
