## Sewer Lateral Inspection · Sample Report

Prepared for a homeowner · Coeur d'Alene, ID area · July 2026

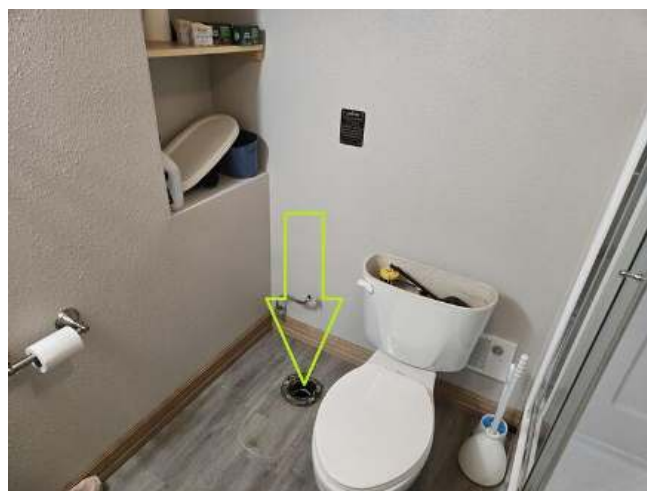
**CAMERA ACCESS**

HOMEOWNER PULLED AND WILL RESET TOILET - RAN CAMERA THROUGH 3" ABS TOILET FLANGE

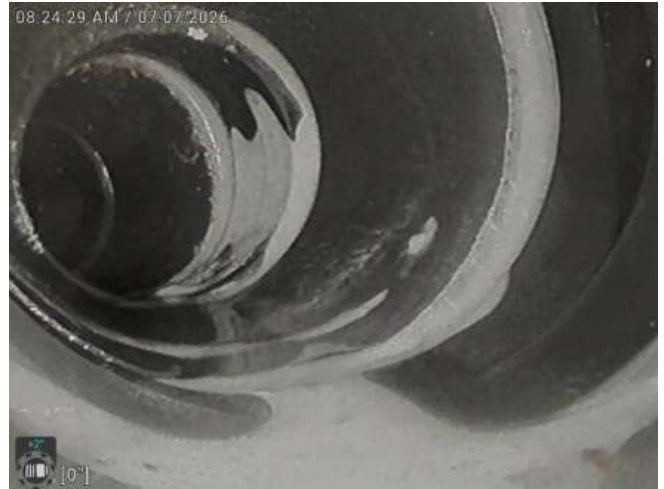
**ABS PORTION OF BUILDING DRAIN**  
CLEAN AND CLEAR IN GOOD STRUCTURAL CONDITION

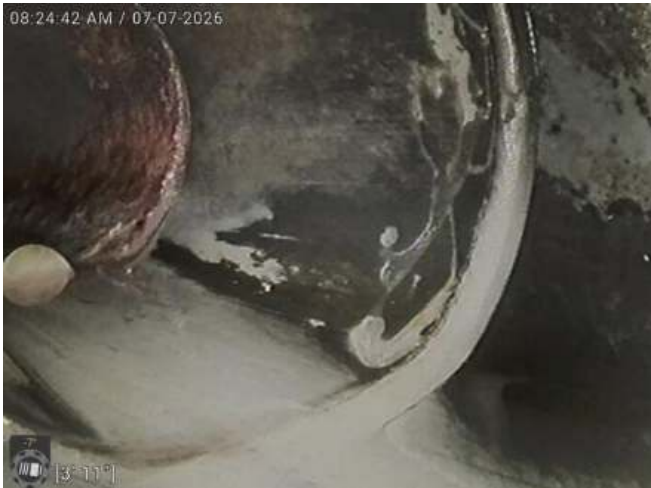
**ABS TO CAST IRON TRANSITION**  
COIN OR OTHER DEBRIS STUCK IN JOINT

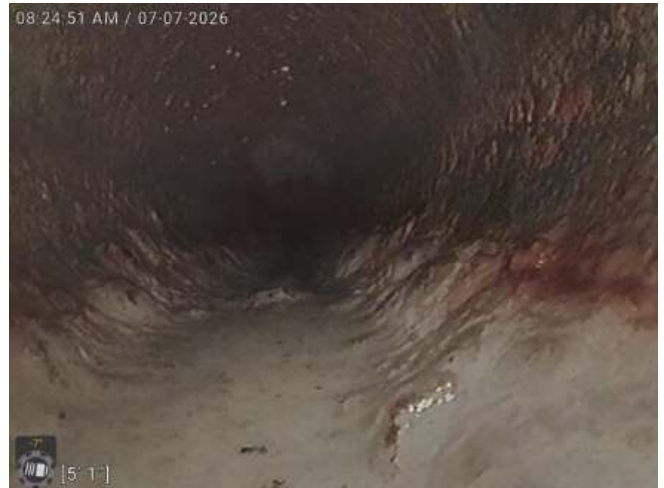
Moderate rust, scale, and corrosion were observed throughout the cast iron portion of the building drain. Minor to moderate root intrusions were noted in the clay lateral piping, with more severe root intrusion at a joint in the clay pipe at 82' as well as at the city main connection. The lateral appears to be maintainable in its current condition. No immediate repairs were necessary at the time of inspection.

**CAST IRON BUILDING DRAIN**  
MODERATE RUST, SCALE, AND CORROSION

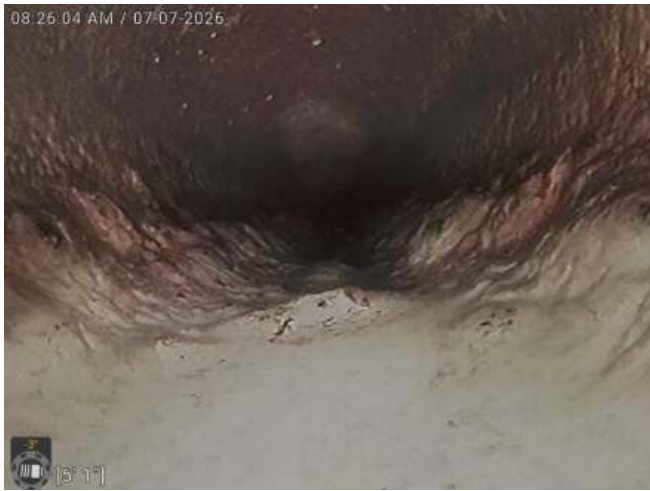
**CAST IRON BUILDING DRAIN**  
MODERATE RUST, SCALE, AND CORROSION

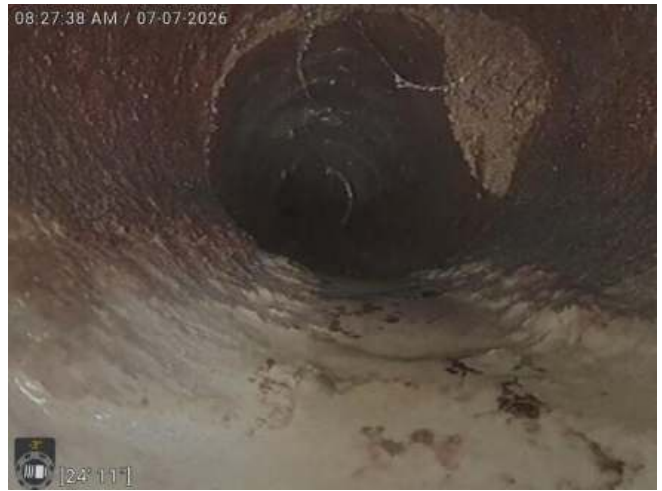
**CAST IRON TO CLAY TRANSITION**  
MINOR ROOT INTRUSION - MINOR ACCUMULATION OF SLUDGE AND SCALE

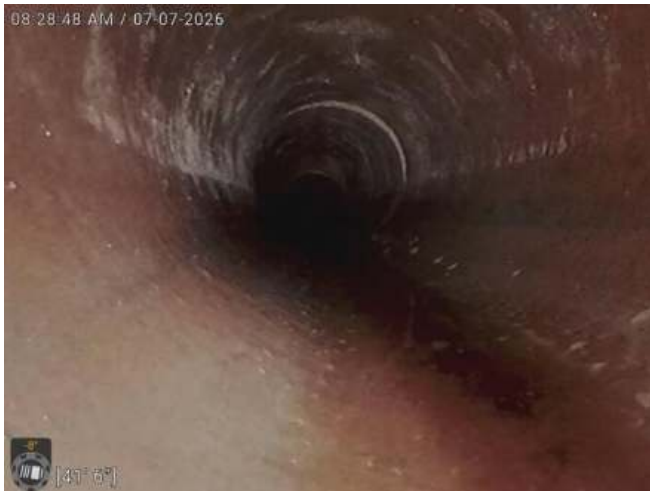
**CLAY LATERAL PIPING**  
CLEAN AND CLEAR

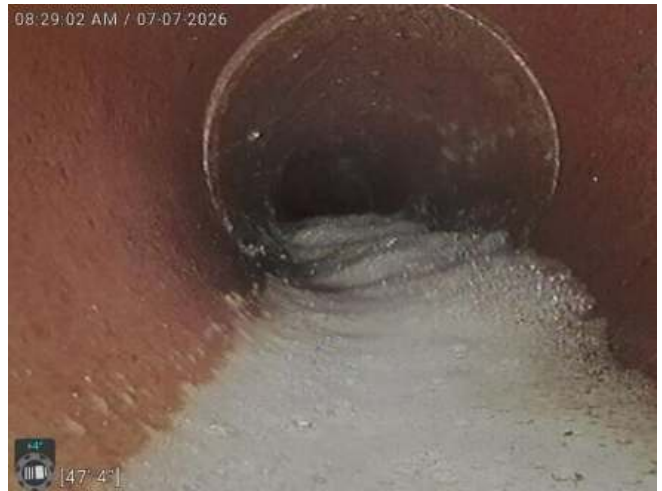
**CLAY LATERAL PIPING**  
MINOR BELLY (LOW SPOT HOLDING WATER) - ACCUMULATED SOAP SUDS

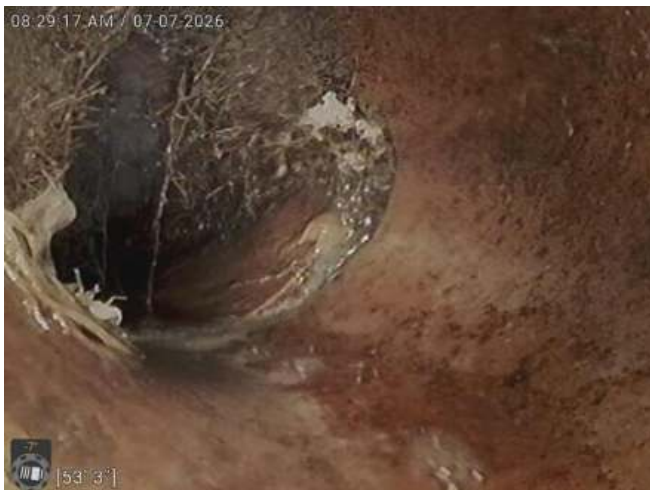
**CLAY LATERAL PIPING**  
MODERATE ROOT INTRUSION AT JOINT

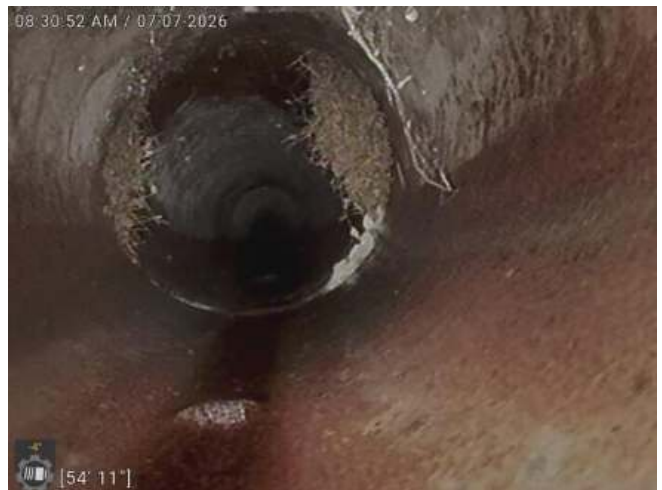
**CLAY LATERAL PIPING**  
MINOR ROOT INTRUSION AT JOINT

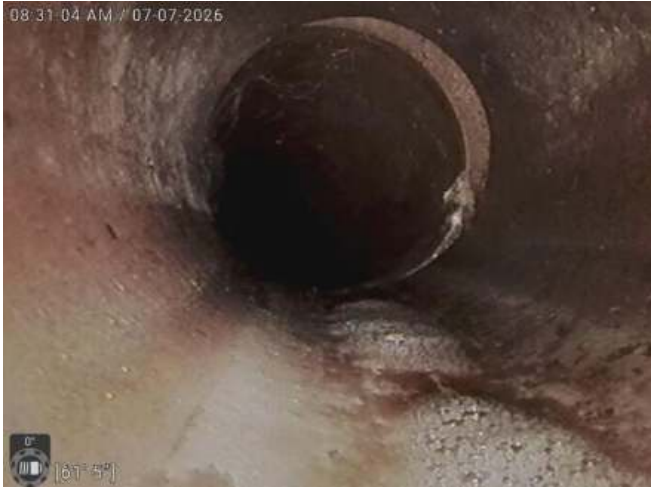
**CLAY LATERAL PIPING**  
MINOR OFFSET AT JOINT

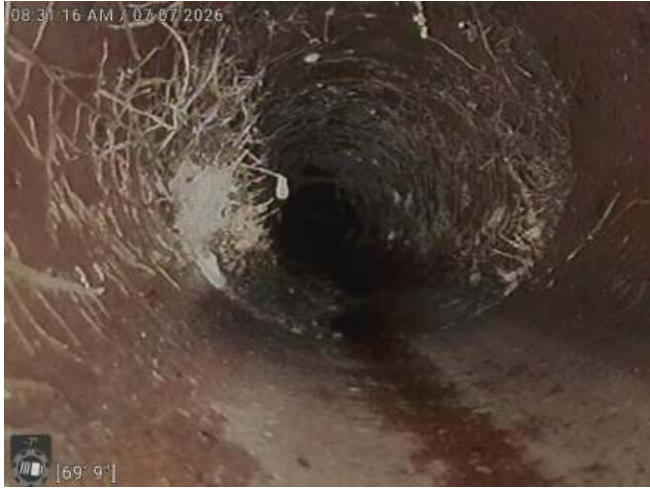
**CLAY LATERAL PIPING**  
MINOR TO MODERATE ROOT INTRUSION

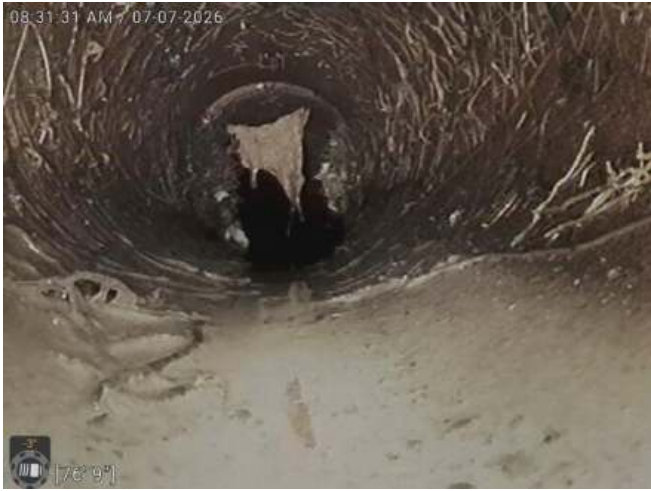
**CLAY LATERAL PIPING**  
MODERATE ROOT INTRUSION - ACCUMULATED PAPER AND WASTE

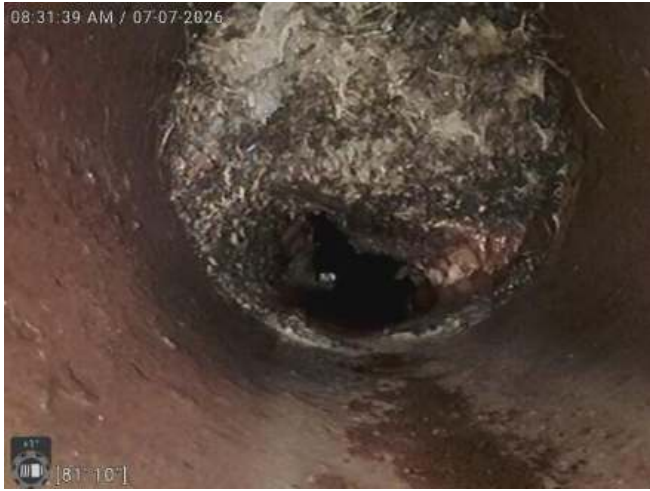
**CLAY LATERAL PIPING**  
SEVERE ROOT INTRUSION AT JOINT - NEAR COMPLETE BLOCKAGE -  
IMMEDIATE MAINTENANCE ADVISED TO PREVENT SEWER BACK-UP

Immediate maintenance is advised. It is recommended to have the building drain and lateral cleaned by hydro-jetting to eliminate root intrusions and accumulated waste. This maintenance should be performed immediately to prevent a backup, and periodically every 2-3 years thereafter.

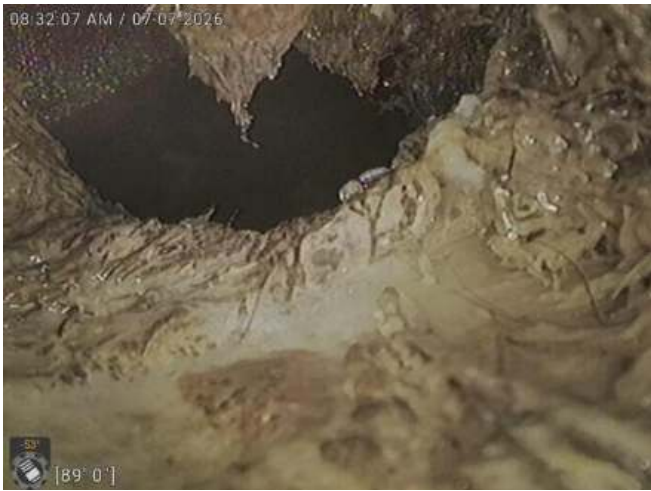
**CONNECTION TO CITY MAIN**  
SEVERE ROOT INTRUSION
