## Septic Lateral Inspection · Sample Report

Prepared for a homeowner · Sandpoint, ID area · July 2026

The 4" building sewers (septic laterals) serving both the house and the shop were video inspected to assess their structural condition and function. The inspection covered accessible lengths from entry points at the house and shop cleanouts, and included digital locating to determine depth and identify tie-ins.

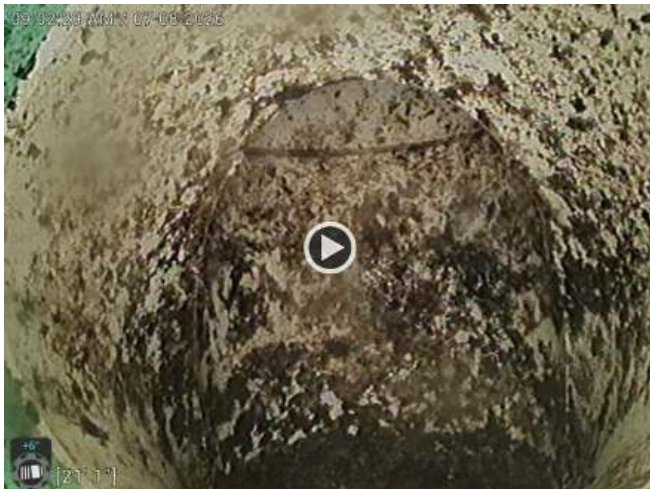
#### HOUSE LINE FULL VIDEO

The house lateral was inspected via the 4" ABS cleanout recessed into the patio on the center northeast side of the house. The cleanout plug was partially concreted over and broke during removal, but was replaced with a new ABS plug. The lateral consists of ABS and PVC piping, running approximately 21' northeast under the patio to the septic tank inlet just off the patio's edge. The line was structurally sound with minor scale accumulation. The PVC sanitary TEE inlet baffle was intact and in good condition. The shop line tie-in was noted under the eastern patio edge. The lateral depth ranges from approximately 2' downstream of the cleanout to 5' at the septic tank inlet. The septic tank riser lid could not be removed due to rusted and rounded-out screw heads, so a visual inspection of the scum layer was not possible. The condition or location of the drainfield is unknown.

No repairs or maintenance were required for the main house line. The shop line appears to be maintainable with routine hydro-jetting, but frequent maintenance may be necessary to prevent backups due to the existing bellies and grade issues. It is unknown when the septic tank was last pumped. It is recommended to have the septic tank pumped every 3-5 years.

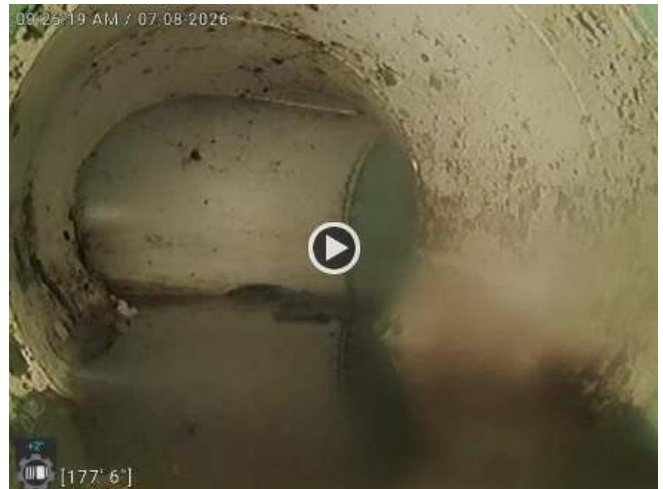
#### SHOP LINE FULL VIDEO

The shop lateral was inspected through the 4" ABS exterior cleanout near the northeast corner of the shop. This 4" PVC line runs at approximately a 45-degree angle for 177' through the yard and under the patio and eastern corner of the house, tying into the main house line just upstream of the septic tank inlet. The shop lateral was in poor condition, with minimal grade/slope and multiple bellies holding water, sludge, paper, and solid waste. Depth measurements were approximately 2' 8" downstream of the cleanout, and 3' 8" at the tie-in with the house line.

Shop - It is recommended to install a dedicated septic system for the shop with guidance from the Panhandle Health District, as frequent ongoing maintenance of the current lateral may be necessary to prevent backup issues. Alternatively, a grinder pump system may be an option to carry waste from the shop to its tie-in with the main house line.
